DVP Refurbishes Guyed Transmission Towers

In the mid 1960s, Dominion Virginia Power (DVP; Richmond, Virginia, U.S.) constructed the first operational 500-kV transmission lines in the United States. These lines traversed a 350-mile circuitous route from the company's Mount Storm Power Station in the Allegheny Mountains of West Virginia to the Piedmont of central Virginia near Richmond. NESC heavy loading criteria formed the basis of the new line design, but with terrain specific additions that included a vertical loading based on a radial ice thickness on the conductors of two inches for the sections in the mountainous regions, and a 70-mph hurricane wind loading. A new family of weathering steel, lattice structures was fabricated to meet the design requirements.

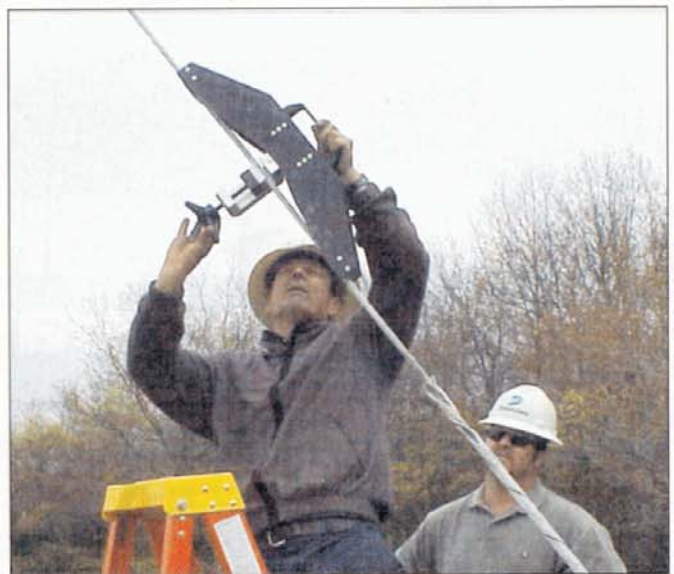
The PIAB RTM 20 D allows crews to determine the tension of a guy before they move it.

Once the rope tension meters arrived, they were field tested on several different tower guy systems. Guy tension values were determined by the PIAB RTM's and then compared with a digital dynamometer's reading. A tension range of 300 lbs or less was common between the devices, but DVP accepted that this difference was reasonable in view of the magnitude of the tensions measured.

The most impressive demonstration of the RTM's capability came when the crew moved to a new site and installed the RTM on the existing guy to check the tension before beginning the changeout. The wind suddenly gusted and the meter's digital

readout started changing to reflect the loading effect the wind was having on the tower and associated conductors.

A second crew was added to this guy grip replacement project. Their response to the use of the PIAB RTM 20 D was much like the first crew, cautious and then complete acceptance. They now have the capability of knowing the tension on a guy before trying to remove it. It provides the information to determine the correct rigging for the change-out. It also was used to re-tension the guy by installing it on the guy as the tension adjustment nuts were tightened.
